**CANADIAN FORCES
FLIGHT SAFETY INVESTIGATION REPORT**

FINAL REPORT

FILE NUMBER: 1010-CF188798 (DFS 2-2-3)
DATE OF REPORT: 21 January 2005

AIRCRAFT TYPE: CF188 Hornet
DATE/TIME: 251214Z June 2003
LOCATION: Aalborg, Denmark
CATEGORY: "B" Category Accident

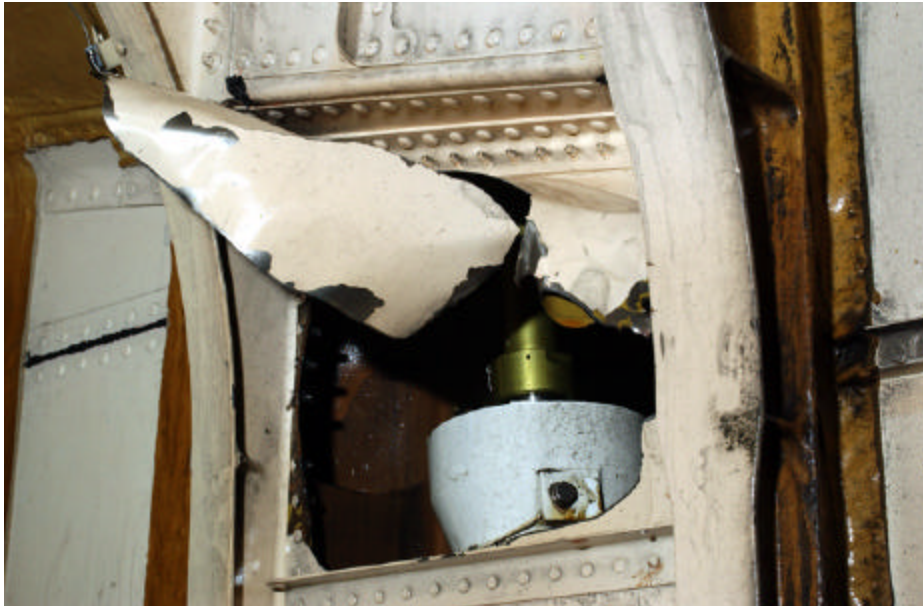
The aircraft received "B" category damage, (photos 1-4) which included damage to both engines, and primary and secondary structure in the region of the tail hook actuator. The most serious damage was sustained to the Y645 former. This former is critical to the structural integrity of the aft fuselage as it provides support for the horizontal stab spindle and actuator mechanism.

Photo 1: Web 74A332537-2037

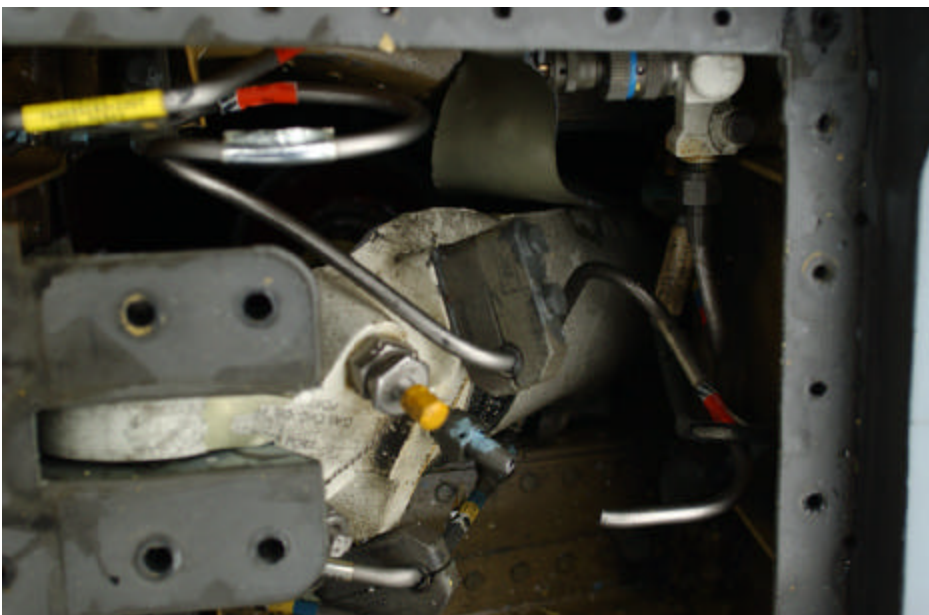
Once aware of the cart pressure, the technician proceeded to open the air charge valve allowing nitrogen from the cart to fill the arrestor hook actuator. The technician saw the actuator gauge reach 600 PSI (max pressure on gauge) and immediately thereafter the pressure accumulator of the hook actuator exploded due to the massive over-pressurization.

The active failure occurred when 3400 PSI was asked for instead of 300 PSI. This was likely caused by an action error, and in particular a memory recall error. In addition, and more importantly, the technician knowingly performed a maintenance procedure without the required qualification or authorization. This being said, some latent pre-conditions existed at the time of this accident. These included the operations tempo at 4 Wing, as well as the number and experience levels of maintenance technicians.

Photo 2: Arresting Hook Accumulator

4.2.1 Critical accumulator limitations such as pressures and quantities should be stencilled on the airframe or marked on appropriate gauges.

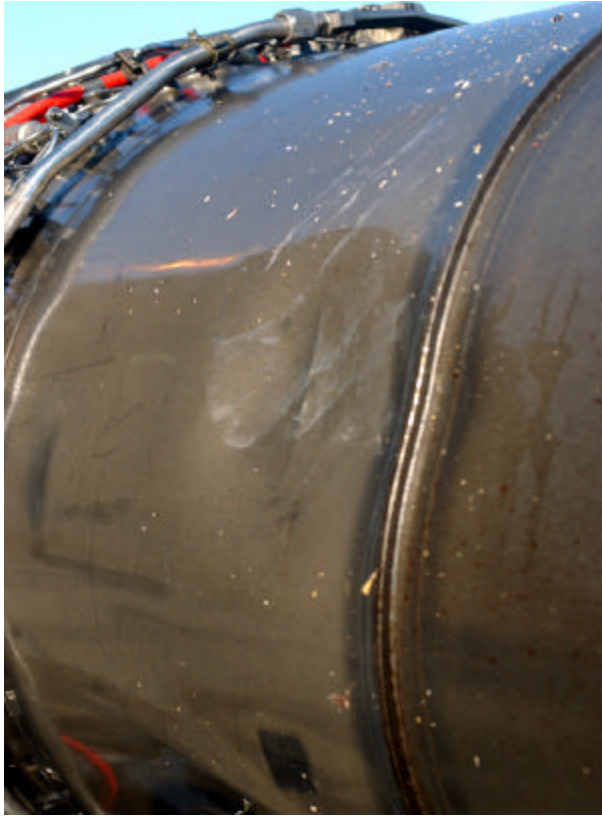
Photo 3: Engine Damage

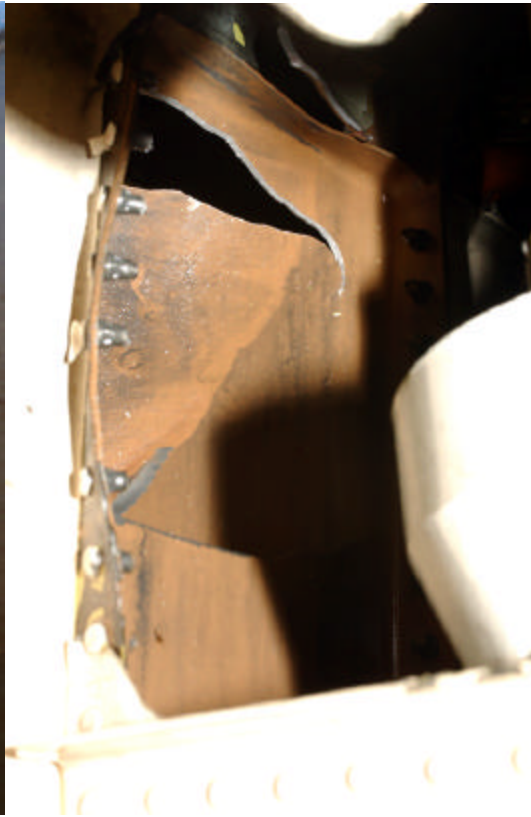
Photo 4: Critical Former
